# Recent water quality incidents and a methemoglobinemia outbreak in infants due to inadequate plumbing of a university hospital's private water supply

ASAMI Mari, MIYOSHI Taro, MIURA Takayuki

Area on Water Management, Department of Environmental Health, National Institute of Public Health

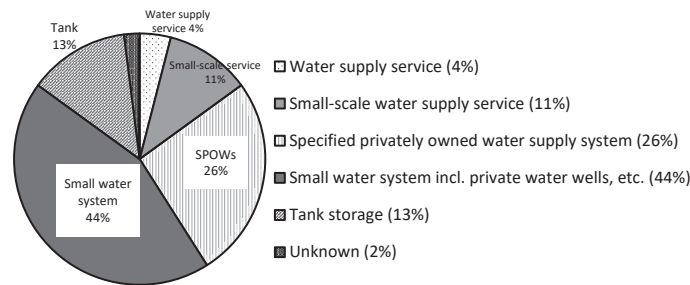
Figure 2 Percentage of water supply types in the water quality incidents with health hazard between 1983 and 2012 (adopted from Kishida et al., 2015 [2]).

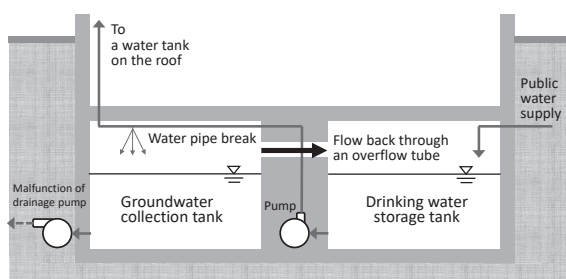
The water storage tank stored water from a public water supply, and the stored water was pumped up to a water tank on the roof, before being distributed to each floor (Figure 3). Water infiltrates in buildings are collected in groundwater collection tanks, and there was an overflow tube from the water storage tank to the groundwater collection tank. A water pipe above the groundwater collection tank was broken, and unfortunately, the drainage pump was out of order. Groundwater flowed into the water storage tank through the overflow tube, and drinking water was contaminated by the groundwater. It is not known why noroviruses were contained in the groundwater, but the building is located in the downtown area of Kobe City and the groundwater surrounding the building could be contaminated by untreated sewage [6]. Noroviruses have been detected in groundwater samples collected in private wells [7], and pathogen contamination in groundwater is one of the major causes of waterborne outbreaks in Japan.

**Figure 3** The water supply system in the commercial building. The drinking water storage and groundwater collection tanks were made of concrete and placed at the basement as part of the building.

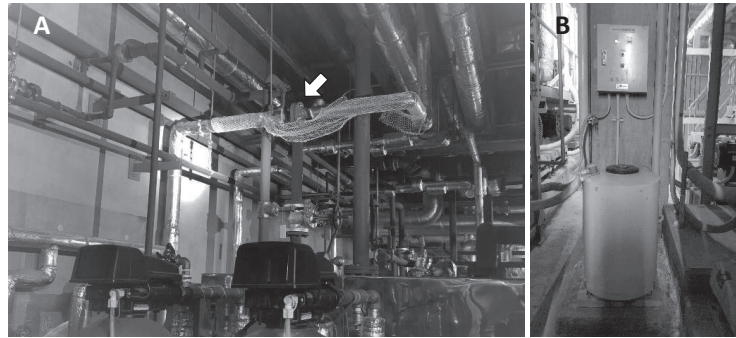
Investigation of the cause revealed that the water piping equipped in air conditioning system and the water piping used in the water supply system had been directly connected by a check valve with a simple structure (Figure 4 [15]) since the construction of the ward approximately 20 years ago. In the piping shown in Figure 5 [15], this connection is not capable of completely preventing backflow from the air-conditioning water piping to that of the water supply system (Figure 6 [15]). On the basis of the results of the investigation, the hospital disconnected the water piping for air conditioning from that for the water supply system as a measure to prevent recurrence. Afterwards, the hospital implemented intensive cleaning of the water supply system piping and confirmed that nitrite was no longer detected.

**Figure 5** The water system in the hospital building. (A) The pipe connected to the air-conditioning system. The part where the check valve was installed is indicated with a white arrow. (B) An anticorrosion agent was injected from a tank with a pump, both of which were installed in the central machine room.

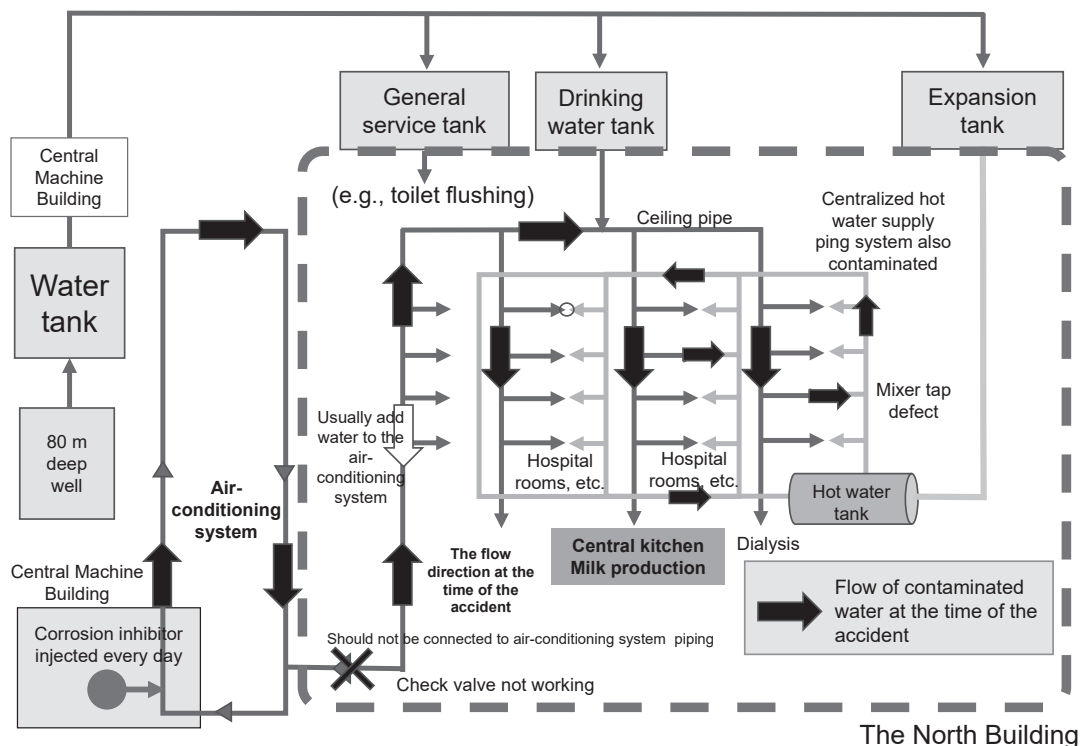
**Figure 6** Schematic diagram of ward piping. Dashed lines indicate wards where accidents occurred. The authors added the contaminated water flow to the Gunma University press release on December 16, 2021 [14].

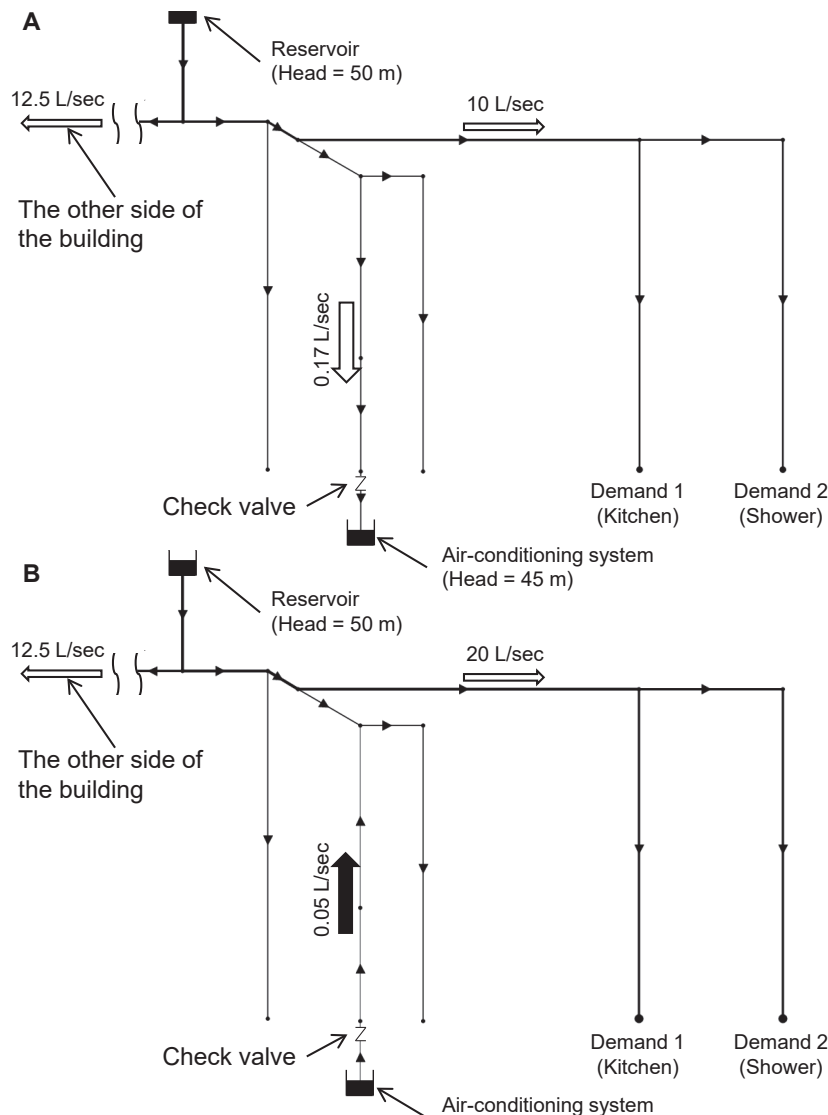
Hydrological simulations in the north building were performed for two cases: base demands at the two nodes adjacent to the piping connected to the air conditioning (i.e., kitchen and shower) were 5 L/sec (Figure 7A) and 10 L/sec (Figure 7B), and the water demands at the kitchen (Demand 1) and shower (Demand 2) were moderately at a higher level. In other words, the water demands of 10 L/sec are within the expected range during the designing of the facility. The reservoir with a head of 50 m described on the top of the two figures corresponds to the rooftop tank from which tap water is distributed to the entire building. Therefore, in usual conditions, all the water in the pipeline described in Figure 7 should be introduced from this reservoir. It should be noticed here that all the simulations were performed

under the assumption that the check valve described in Figure 7 did not work properly. Therefore, both upward and downward flows were possible in the piping connected to the air-conditioning system.

In case the water demand in both Demands 1 and 2 is 5 L/sec (Figure 7A), water in the piping connected to the air-conditioning system flows downward with a flow rate of 0.17 L/sec. As mentioned earlier, this flow regime is normal and in accordance with the design concept. Conversely, upward flow with a flow rate of 0.05 L/sec is expected to be generated when the water demands in both Demands 1 and 2 increased to 10 L/sec (Figure 7B). This alteration in the flow direction is attributed to the elevated head loss in the piping adjacent to the “Reservoir” shown in Figure 7

**Figure 7** Hydraulic simulations of the flow in the hospital building. Temporal water demands at Demands 1 and 2 are (A) 5 L/sec (22.5 m<sup>3</sup>/day), and (B) 10 L/sec (45 m<sup>3</sup>/day). The check valves described in this Figure 7 did not work properly; both upward and downward flows were possible in the piping connected to the air-conditioning system.

(i.e., rooftop tank). As the water usage in Demands 1 and 2 increased, the flow rate in the piping connected to the rooftop tank also increased. Increase in flow rate results in increase in friction loss and decrease in the available head at the branch of the piping connected to the air-conditioning system. Eventually, the head of the air-conditioning system overcomes the one associated with the rooftop tank. In such situations, a reverse flow from the air-conditioning system to the piping of the water supply system could occur.
